## **St Hubert's Church, Idsworth.**

### **Report on fabric repairs, July – October 2019**

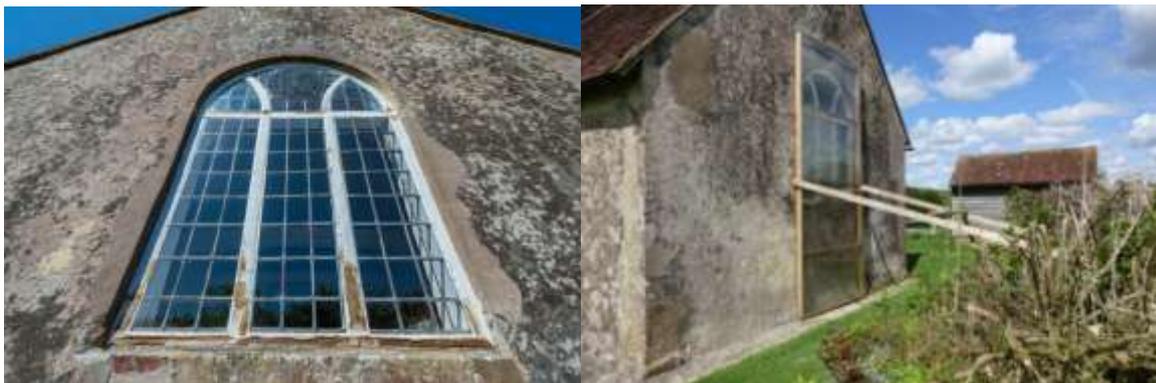
The Quinquennial Report of 2016 highlighted a number of urgent repairs to make the church watertight and prevent further deterioration of the building and its precious wall paintings. Major urgent structural repairs were needed for all windows, the north and east walls and the chancel fabric. The church is in an elevated position and takes the brunt of the wind and weather. The east wall was particularly vulnerable and its large window liable to collapse. A temporary exterior screen was installed on to the east window in late 2017.

*East window exterior, before and after temporary protection added*

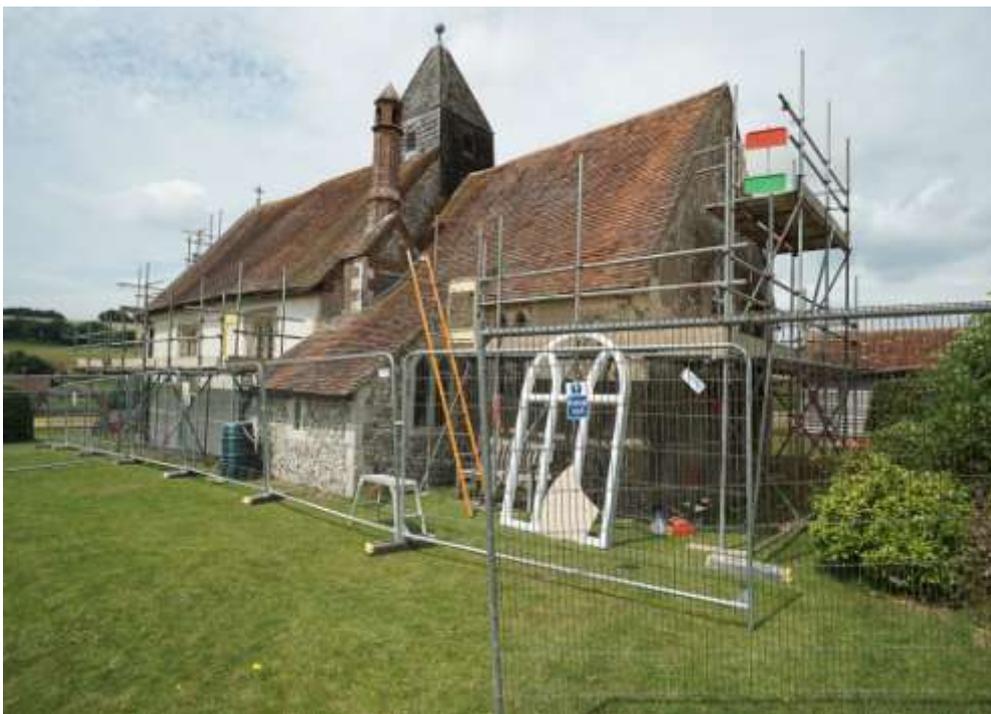
*July 2019, scaffolding in place, new window frame ready*

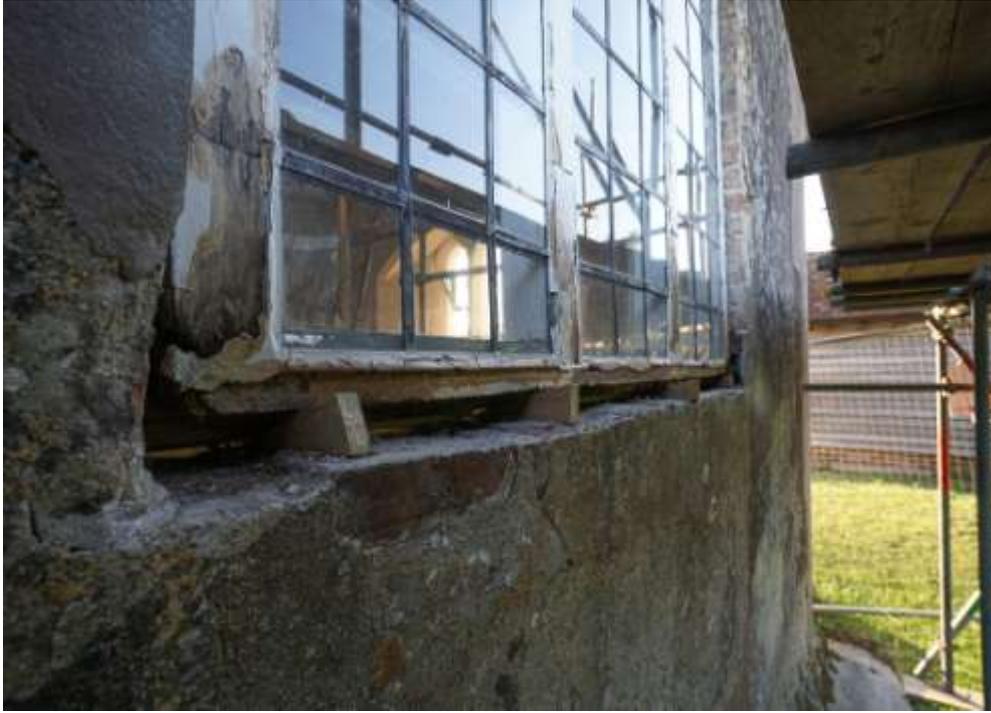
*July 2019, work begins to remove old window*

The removal of the east window was the most challenging part of the work and was supervised at all times by the paintings conservator. The original glass, including the stained glass roundel depicting the conversion of St Hubert, was carefully removed, retained and cleaned. The window opening was then shuttered and the cement render was removed from the east wall. This was also challenging as the architect had specified that only non-impact tools could be used in the process.

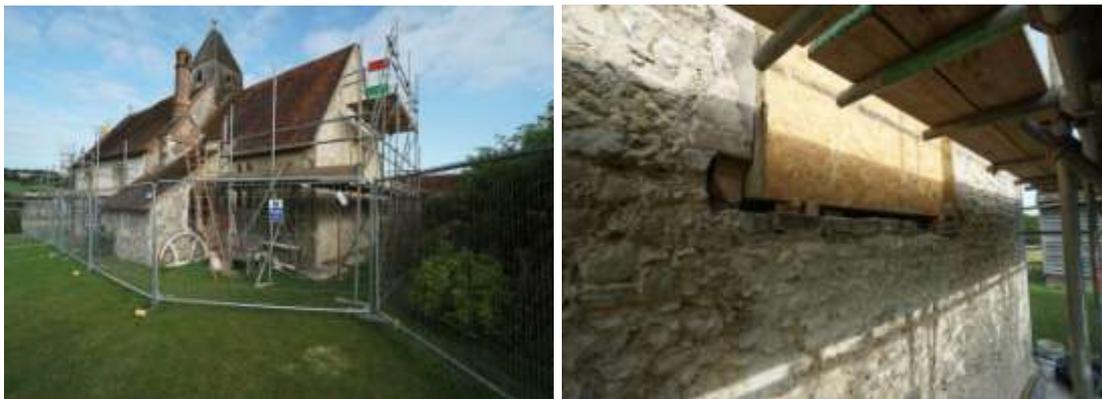
*August 2019, east window removed and temporary boarding in place*

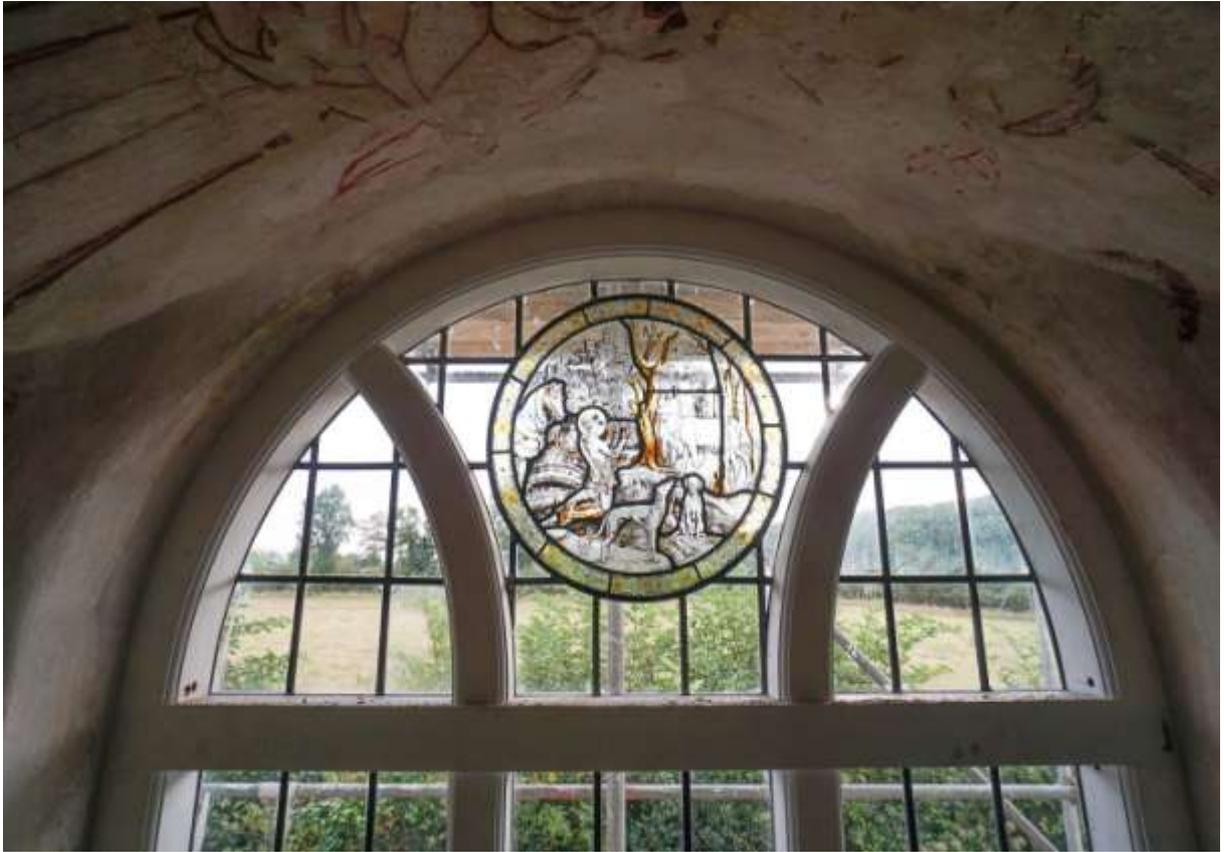
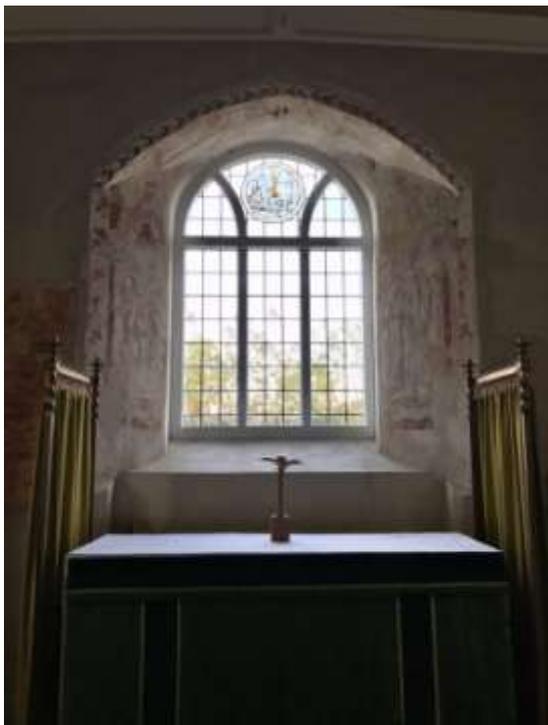
*Interior views of new window, re-leaded with original glass replaced*

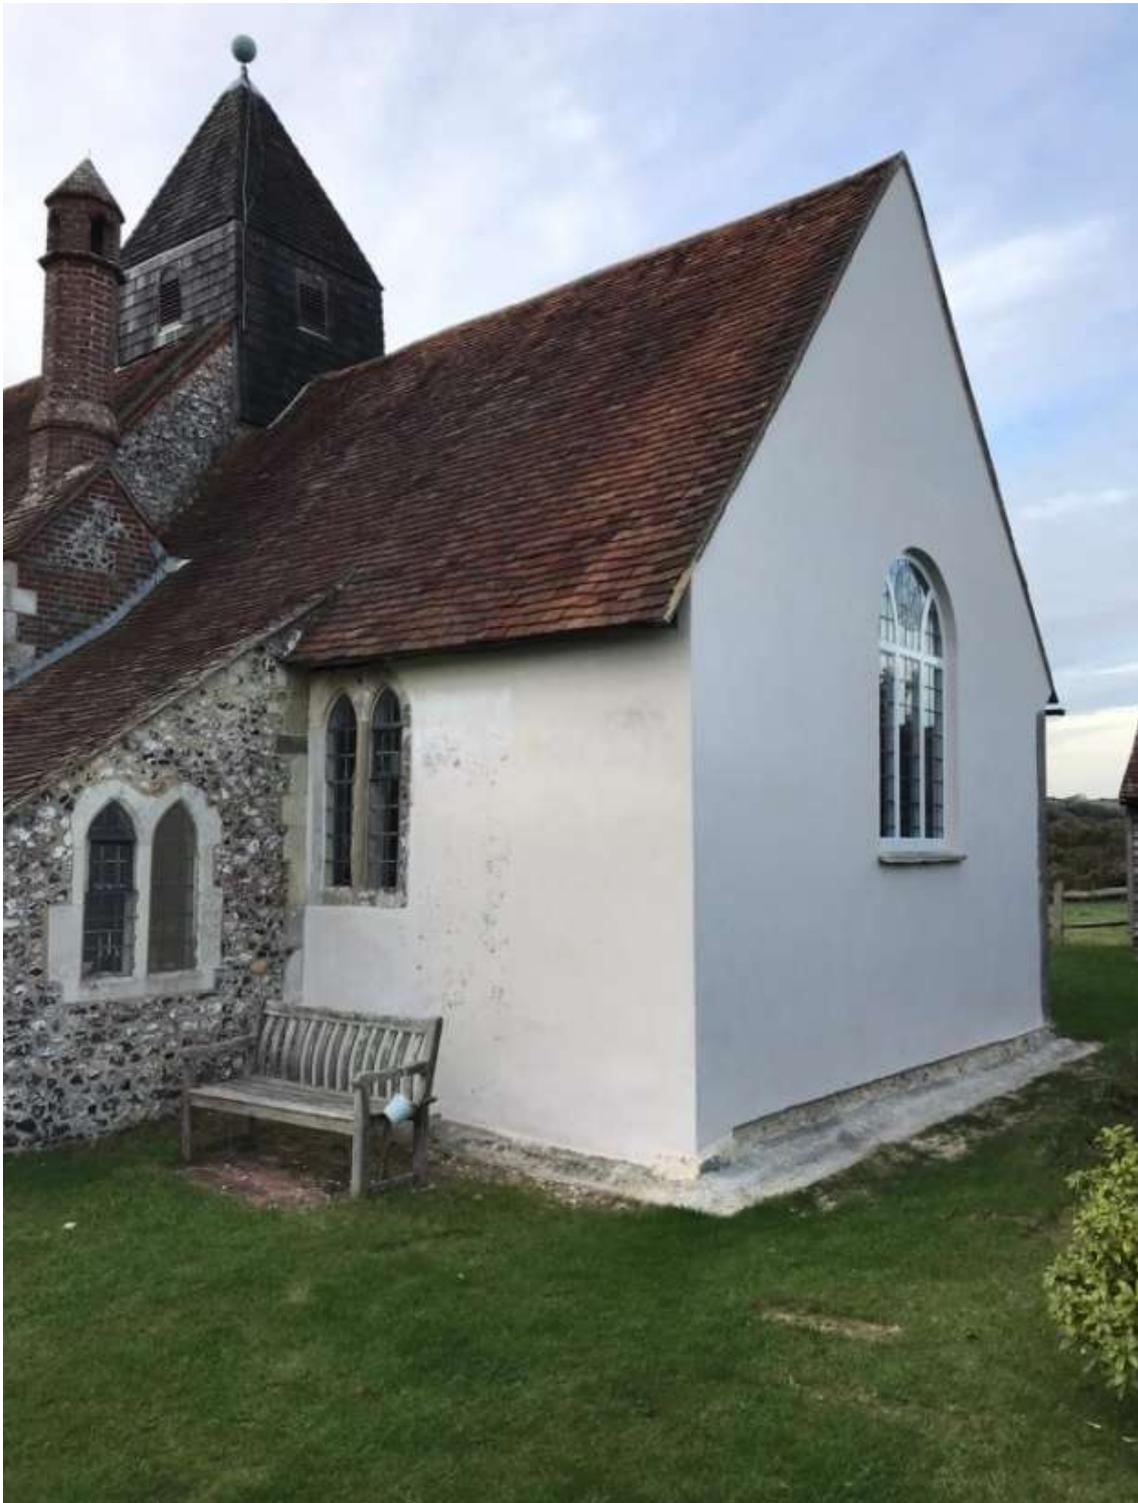
*Exterior view, new window east wall*

With the old render stripped back, an interesting feature in the wall was discovered by the architect: set at regular intervals in two layers across the wall were sets of sandstone blocks in an inverted 'v' formation. These were 'puglestones' and were the supports for the original wooden scaffold poles when the wall was built dating back to at least the time of the 14<sup>th</sup> Century wall paintings. The wall was then rendered, given three coats of limewash and the glass installed before final pointing around the window frame, inside and out, was applied by the conservator.
